**BRAY LAKE DAM  
PHELPS COUNTY, MISSOURI  
MO 30098**

# **PHASE 1 INSPECTION REPORT NATIONAL DAM SAFETY PROGRAM**

**PREPARED BY: U.S. ARMY ENGINEER DISTRICT, ST. LOUIS**

**DECEMBER 1979**

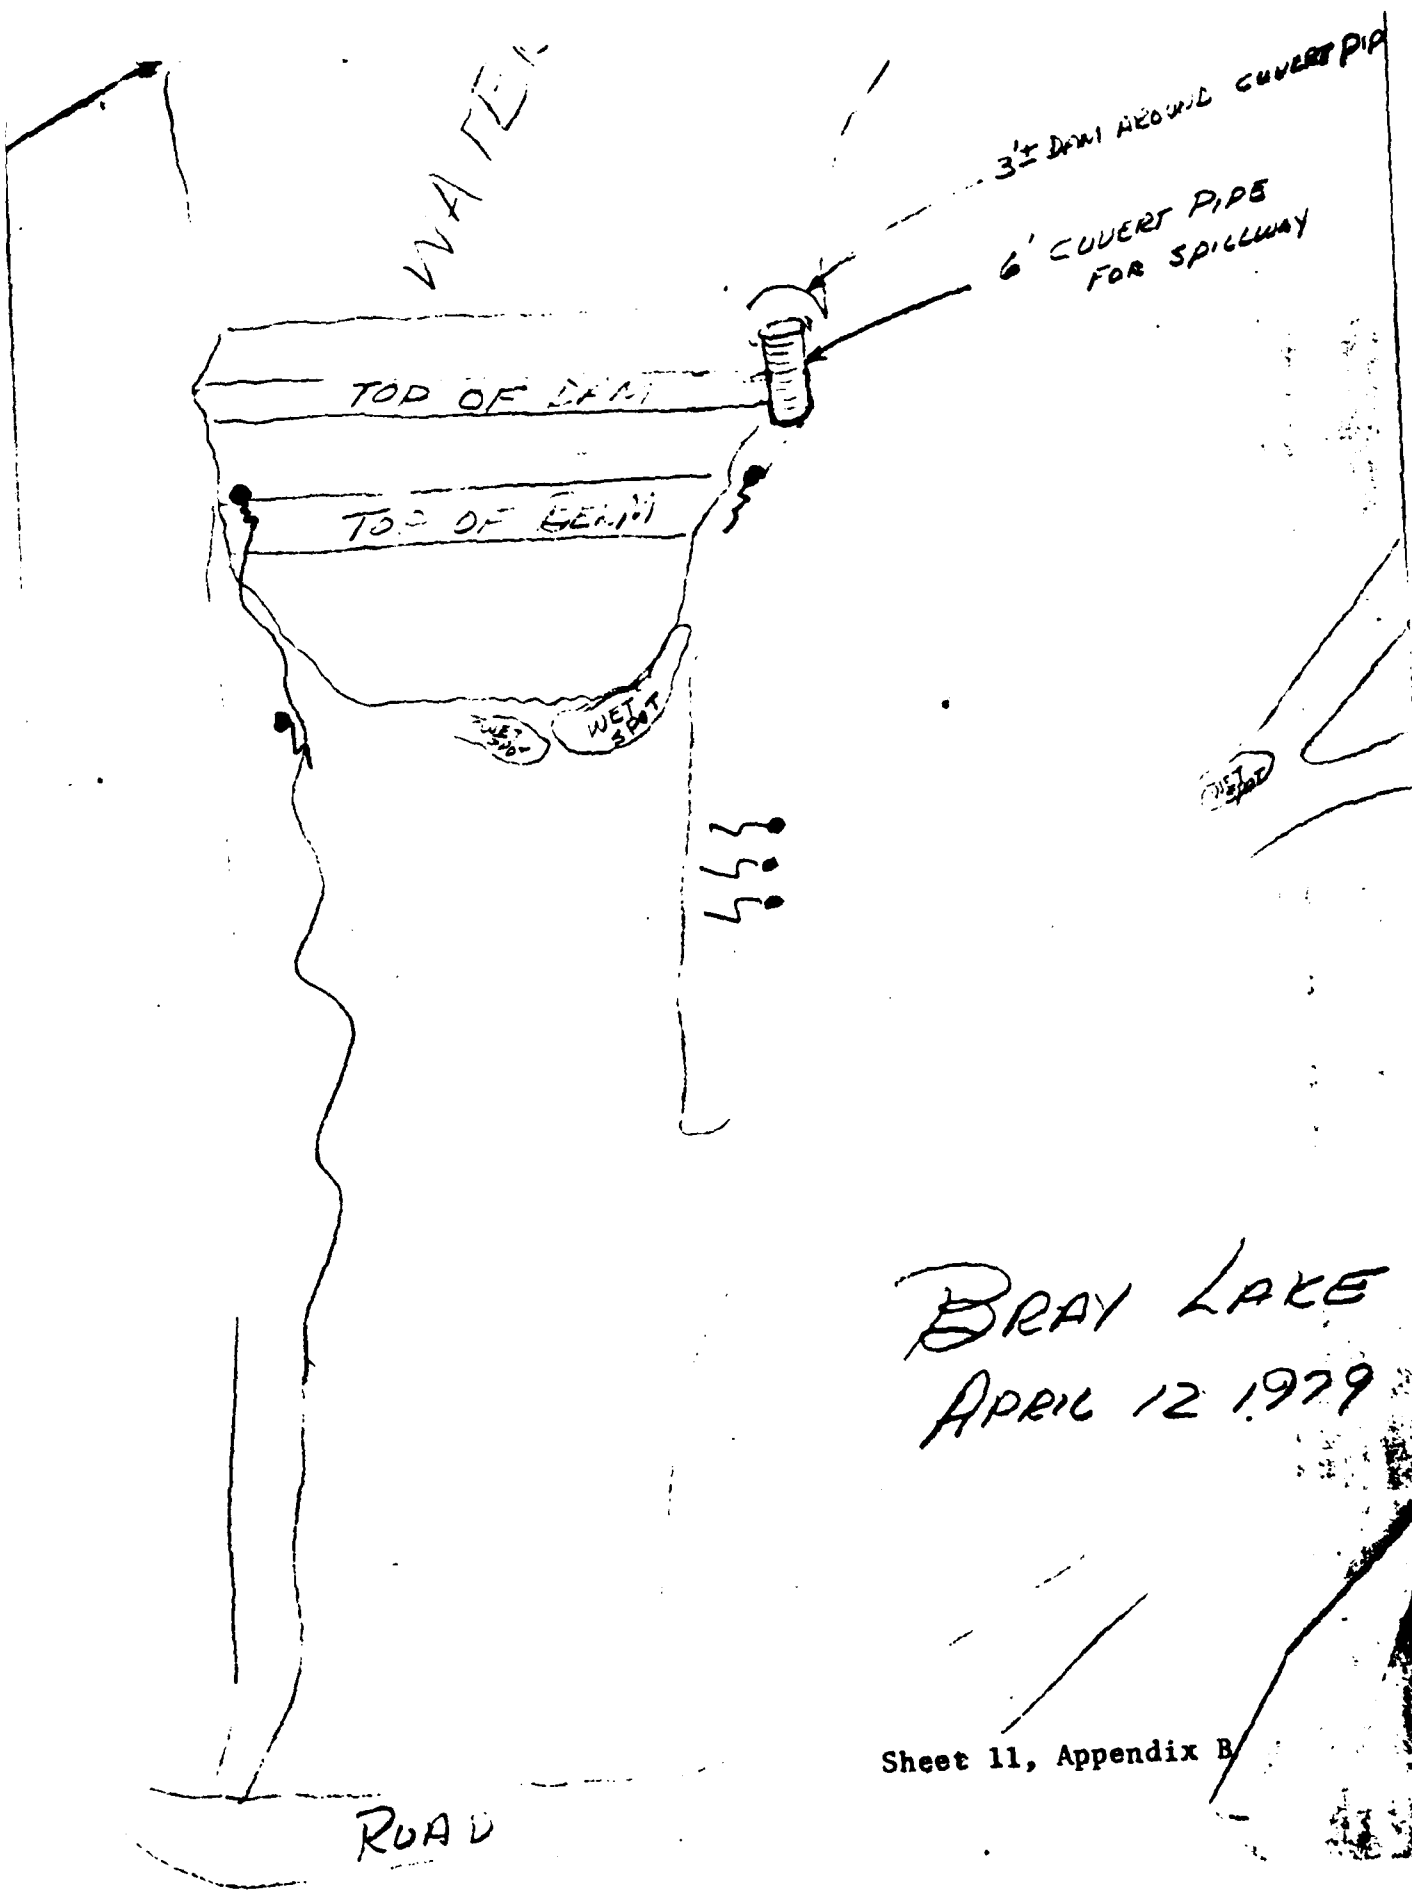
BRAY LAKE  
APRIL 12 1979
